DOT/FAA/AR-95/102

Evaluation of Approach Path Indicator Systems for Heliports

Final Report

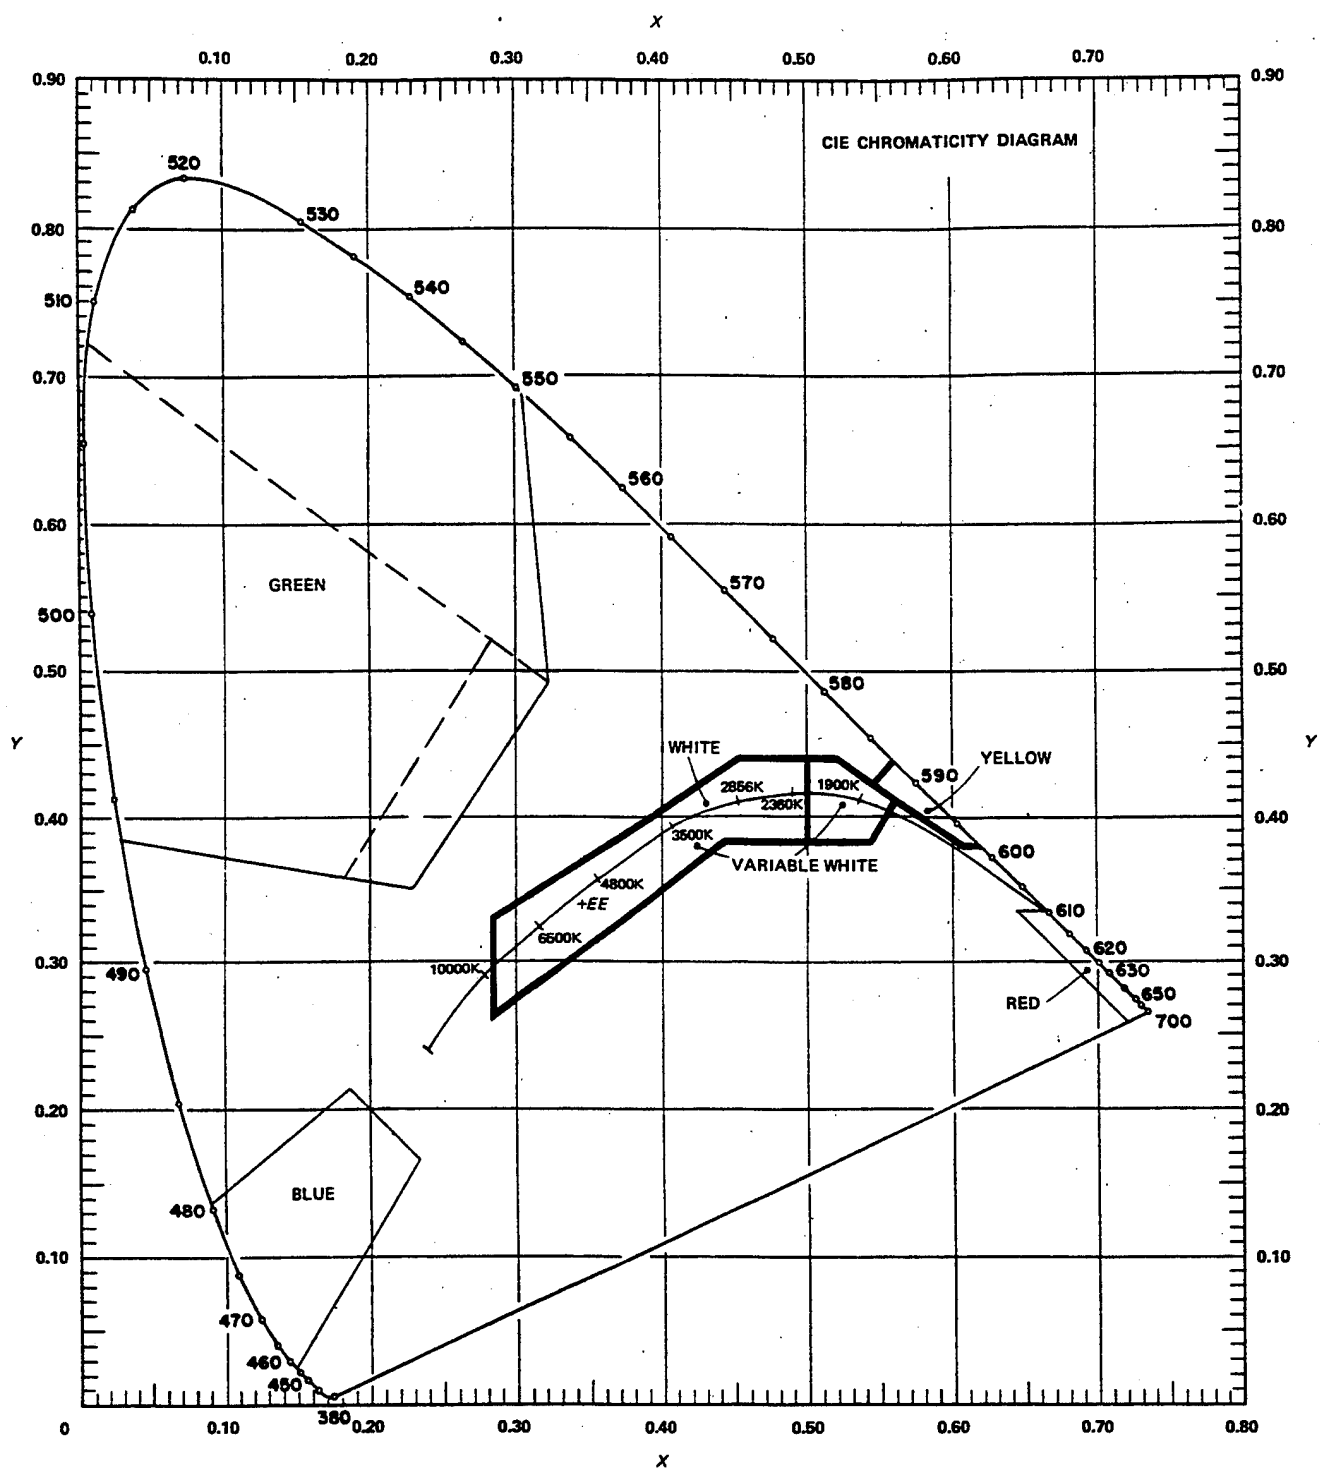
FIGURE 5. CIE CHROMATICITY DIAGRAM (ICAO ANNEX 14, VOL. I)

PAPI SYSTEM LUMINOUS INTENSITY MEASUREMENTS. The first photometric testing conducted was to determine the projected beam spread of the units. Horizontal beam spreads of ± 10 degrees are required by the FAA advisory circulars. The total horizontal coverage for the PAPI system was ± 10 degrees for the white light and ± 9 degrees for the red corridor. The total vertical coverage was 11 degrees for the white sector and 8 degrees for the red sector. The Y-coordinate of the red light was measured to be 0.3092 and falls within the specified boundary of 0.320 (see figure 5).

Paragraph 12 of ICAO's Annex 14, Volume II, states that the transmission factor of a red or green filter shall not be less than 15 percent at the maximum intensity setting. The transmission factor of the red filter of the PAPI system was between 18 and 22 percent. The filter used in this particular PAPI system was an absorption filter.

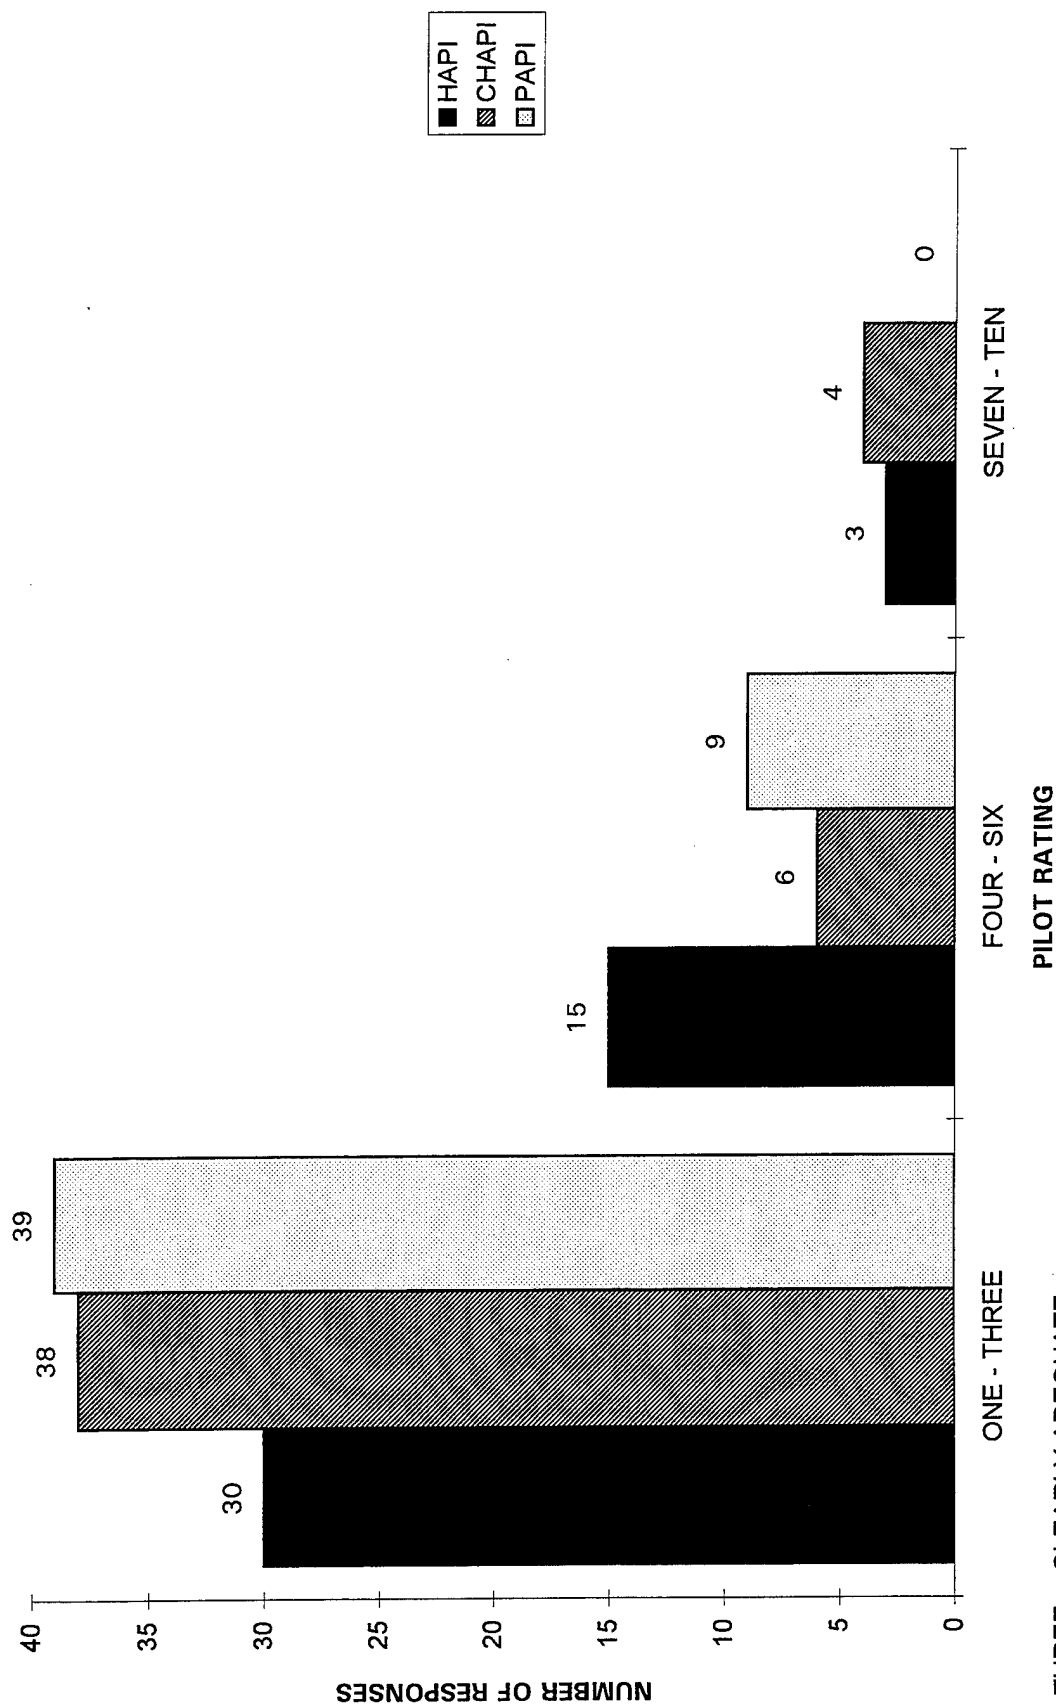
Question 1: Acquisition and Identification of system

ONE - THREE -- CLEARLY ADEQUATE
 FOUR - SIX -- ADEQUATE/MARGINAL
 SEVEN - TEN -- INADEQUATE

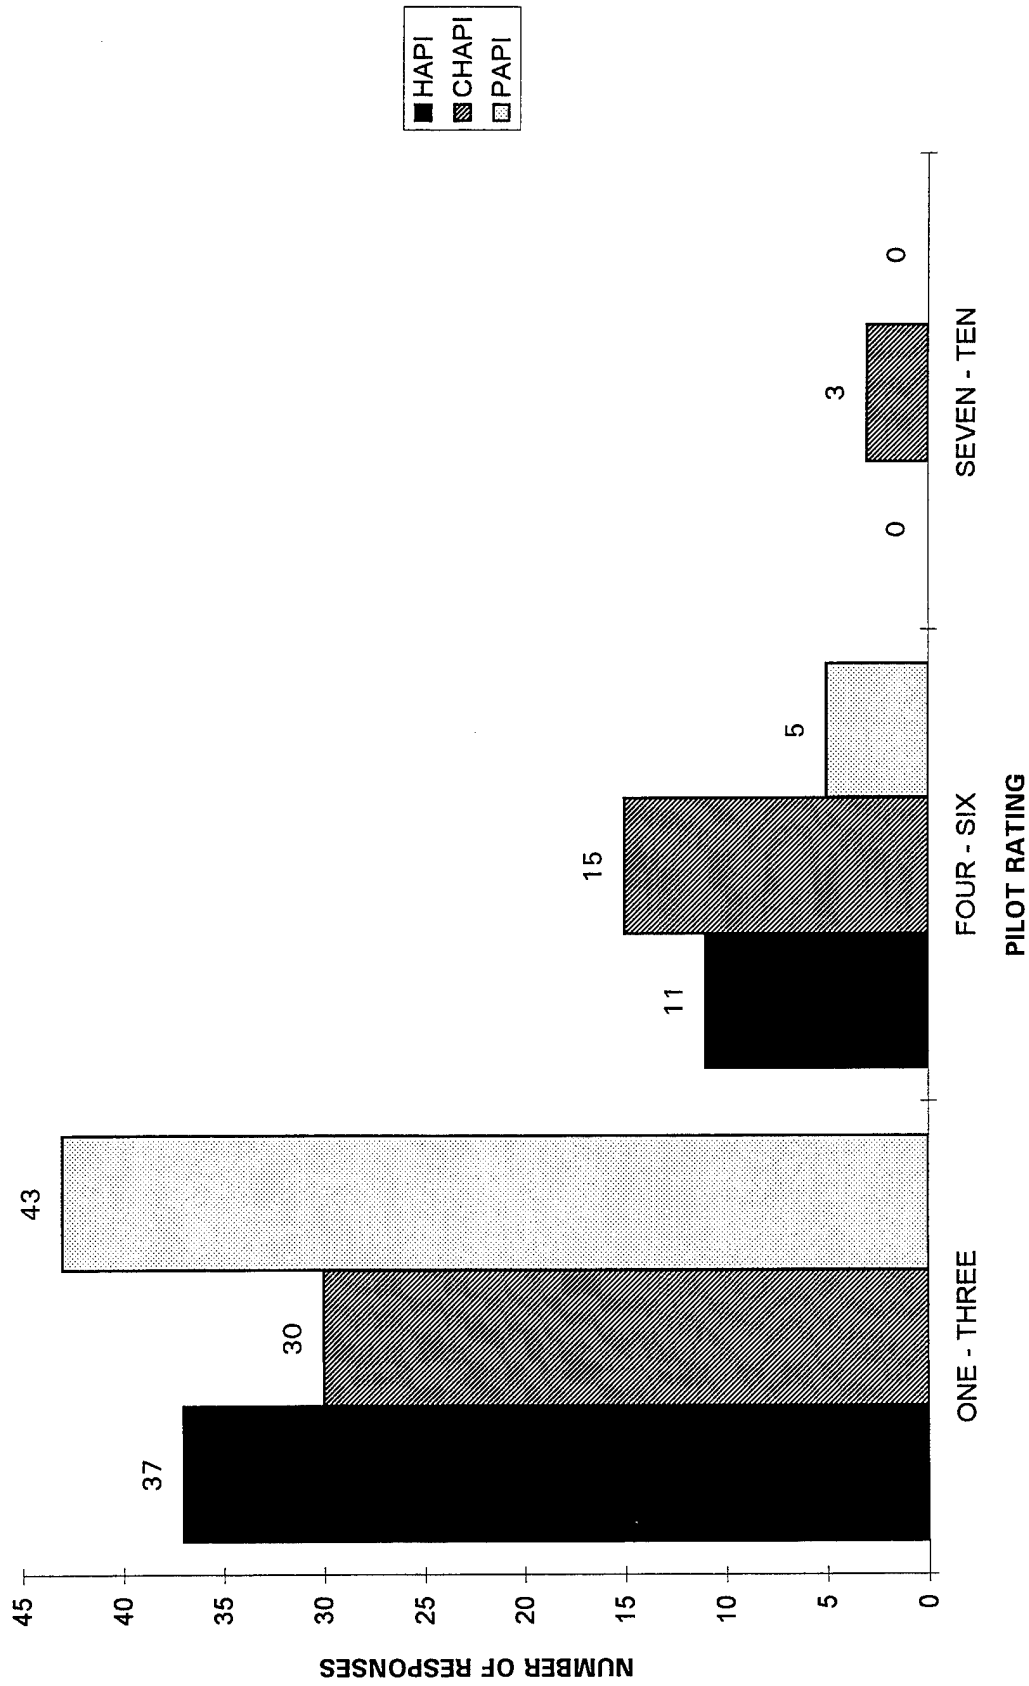
Question 2: Ability to interpret the system signals

ONE - THREE -- CLEARLY ADEQUATE
 FOUR - SIX -- ADEQUATE/MARGINAL
 SEVEN - TEN -- INADEQUATE

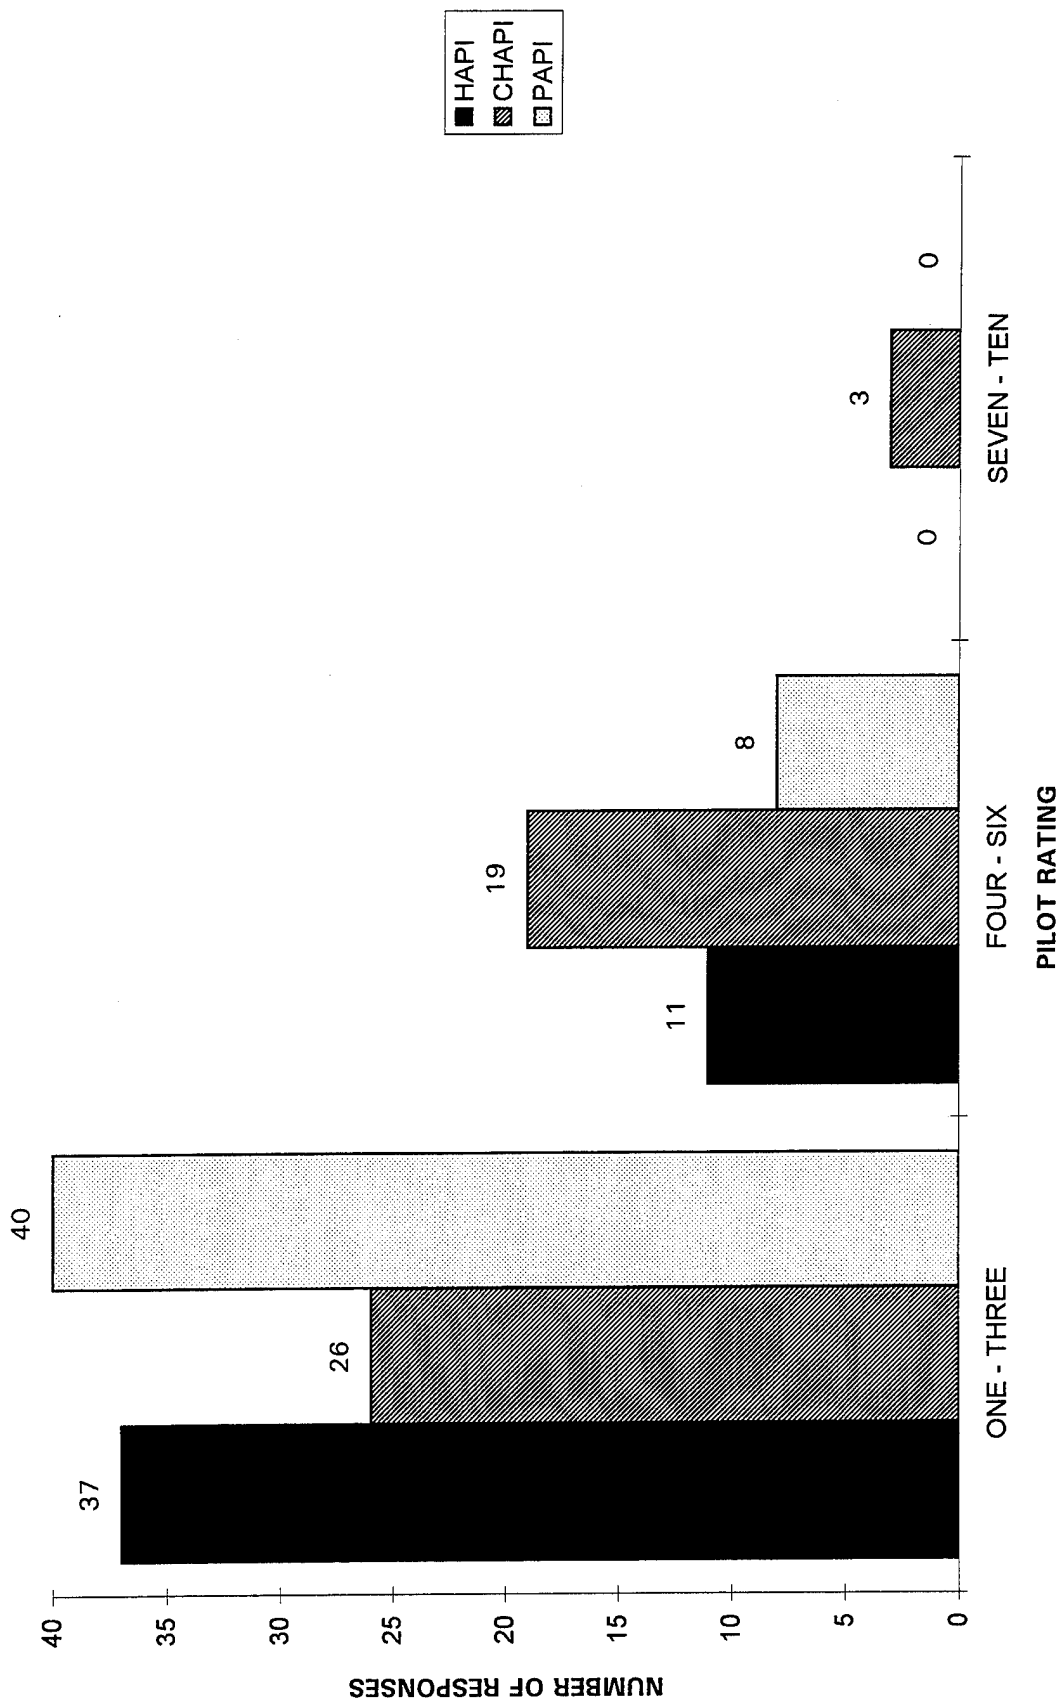
Question 3: Ability to maintain desired glide path signal

ONE - THREE -- CLEARLY ADEQUATE
 FOUR - SIX -- ADEQUATE/MARGINAL
 SEVEN - TEN -- INADEQUATE

3. Ability to maintain desired glide path signal. The PAPI and CHAPI systems had a 1° on glide slope signal and the HAPI had a $3/4^\circ$ on glide slope signal. This question was asked to determine if the on glide slope signals were too tight or too loose. The very high number of responses in the 1 to 3 range for the HAPI and PAPI systems indicated that the $3/4^\circ$ to 1° on glide slope signal widths were ideal for helicopter operations.

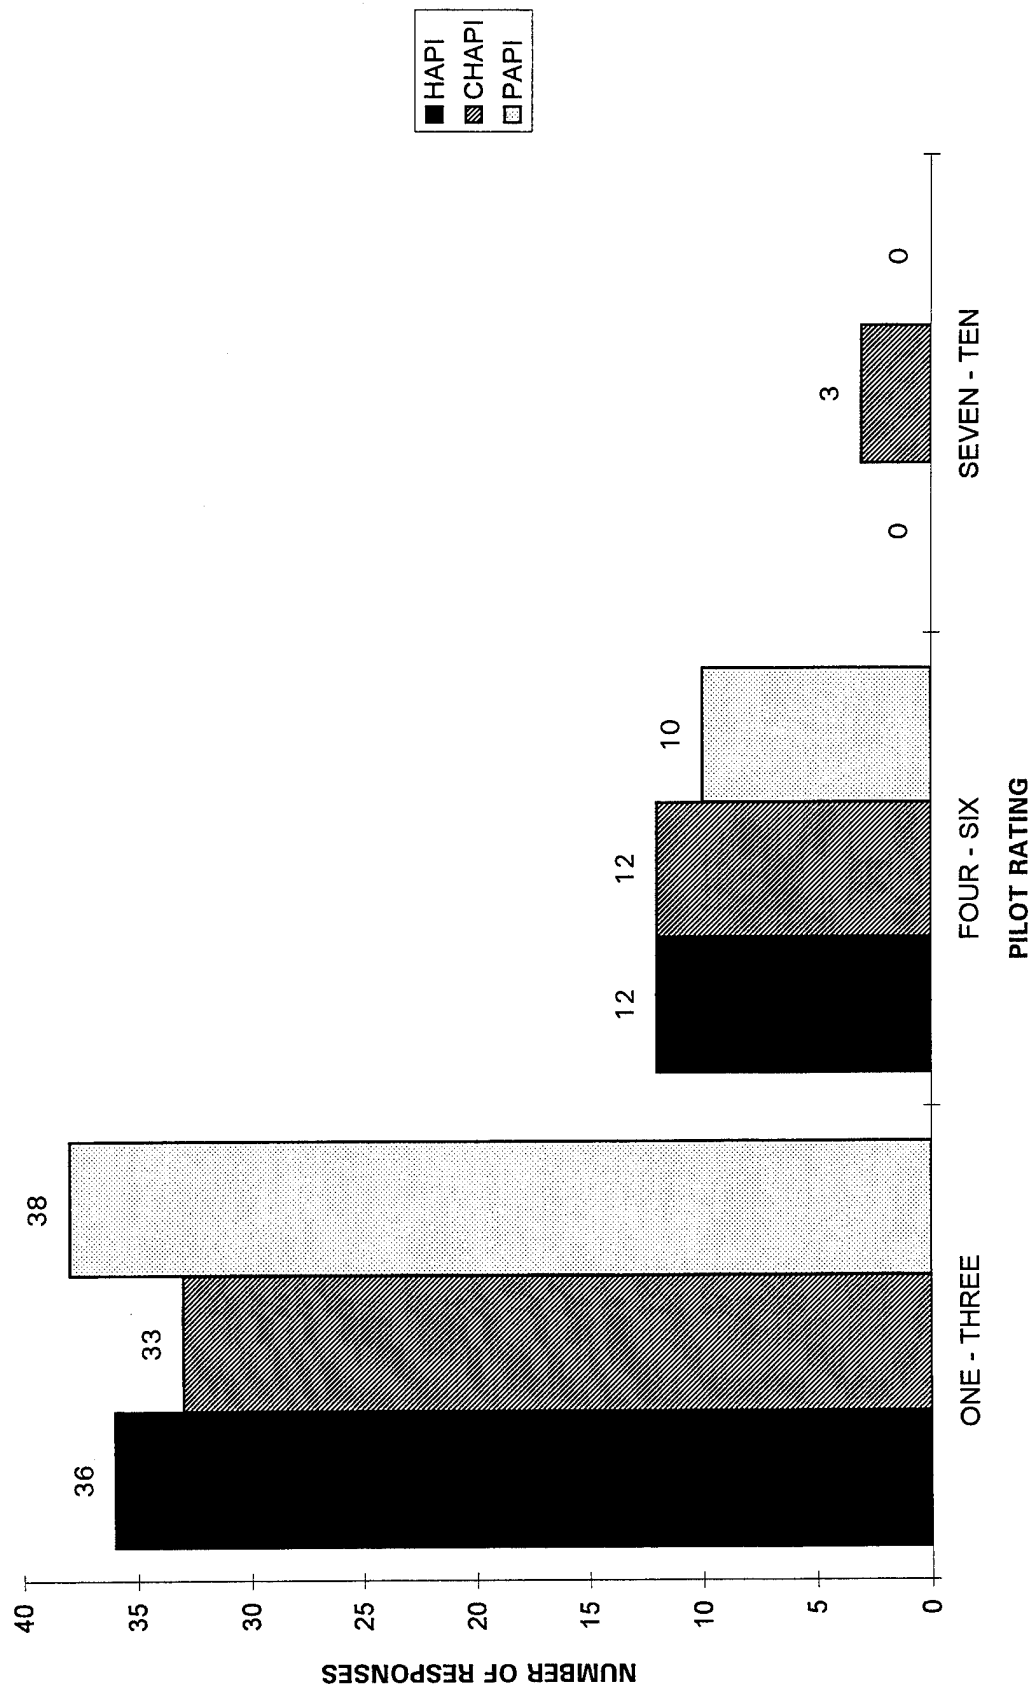
Question 4: Ability to determine deviations from glide path

ONE - THREE -- CLEARLY ADEQUATE
 FOUR - SIX -- ADEQUATE/MARGINAL
 SEVEN - TEN -- INADEQUATE

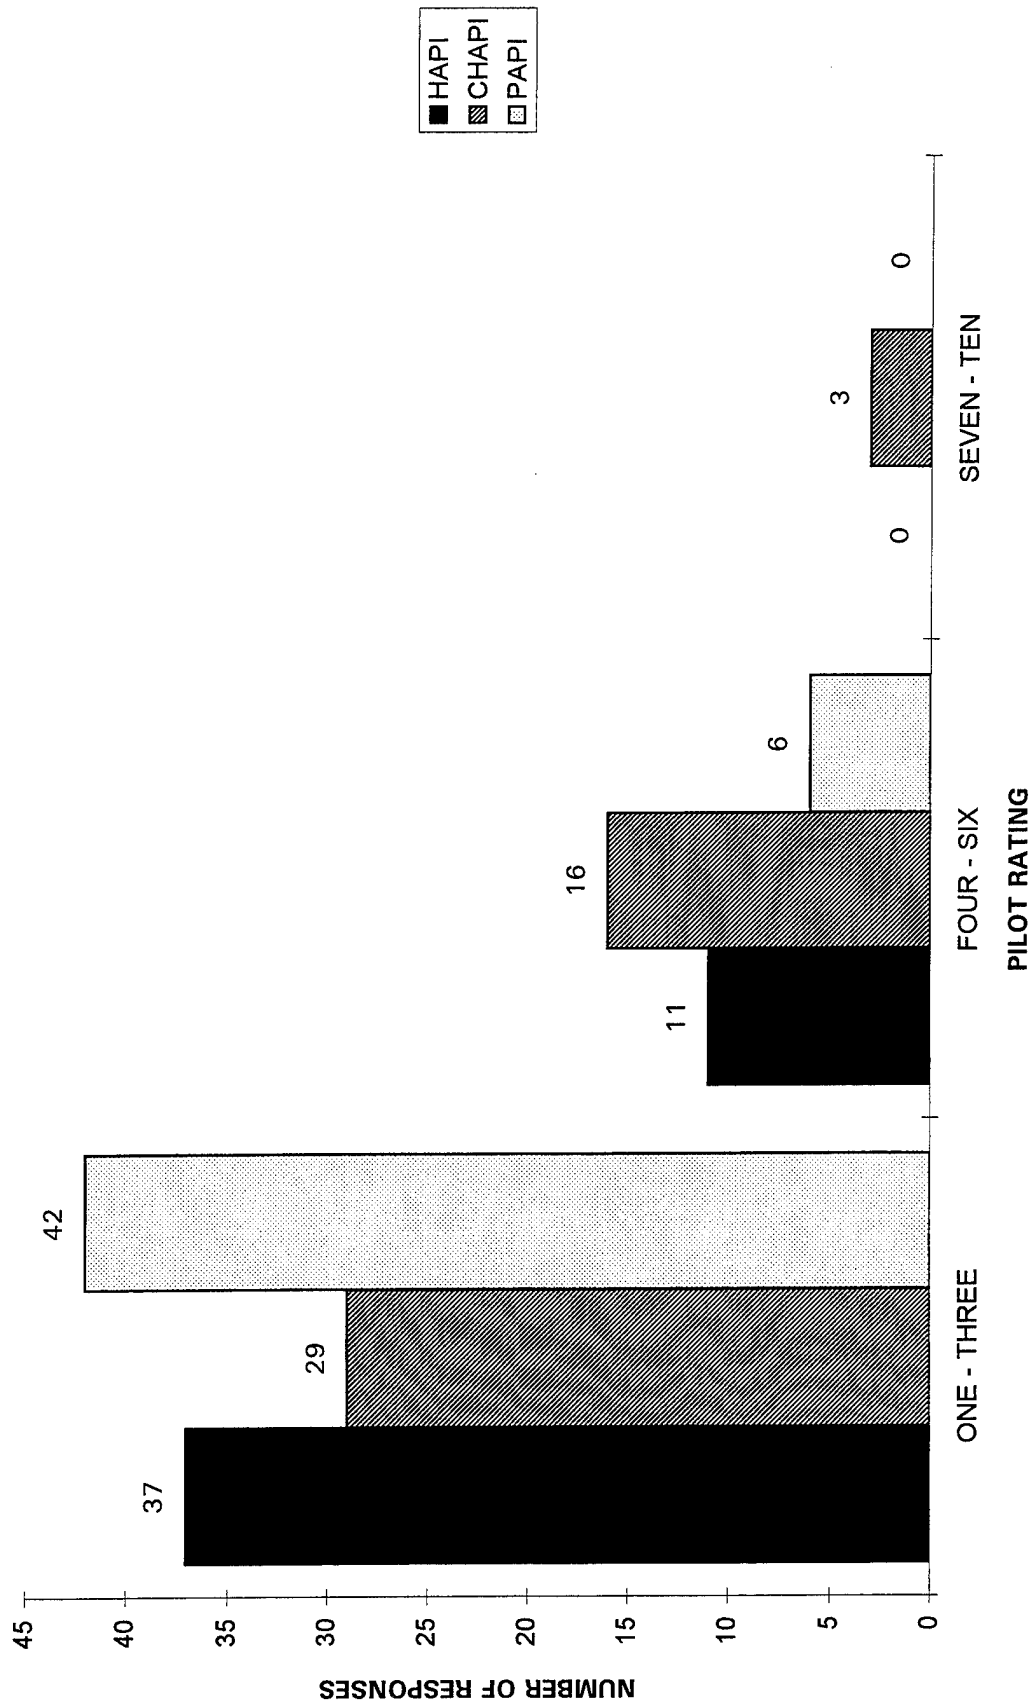
Question 5: How would you rate the workload needed to fly the approach using this glide slope indicator?

ONE - THREE -- CLEARLY ADEQUATE
 FOUR - SIX -- ADEQUATE/MARGINAL
 SEVEN - TEN -- INADEQUATE
